Dorra ABID, Ahmed KTARI, Dhouha MELLOULI, Nedja GAFSI, Nader HADDAR - Failure analysis of shot-sleeves used in brass high pressure die-casting process - Engineering Failure Analysis - Vol. 104, p.177-188 - 2019

# Failure analysis of shot-sleeves used in brass high pressure die-casting process

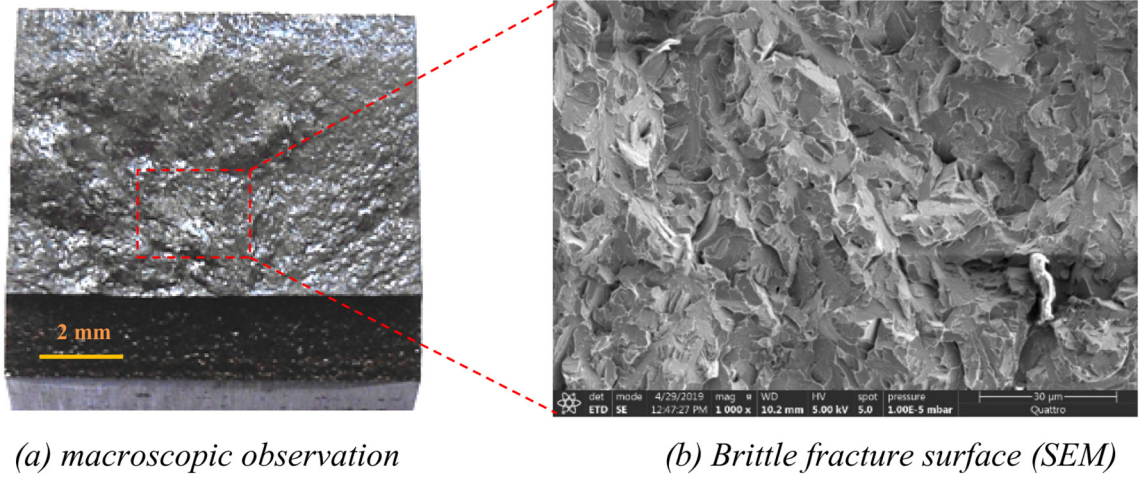
Fig. 5. Fracture surface of Charpy specimen. (a) macroscopic observation, (b) binocular microscope observation.

Standard Charpy V-notched specimens were machined from the failed shot-sleeve by a wire EDM machine (Fig. 4). Then, three tests were conducted at room temperatures to determine the material toughness. The average of the measured CVN energy ( $CVN = 3.4 \pm 0.1$  J) and the feature of the fractured surface prove the brittle nature of the specimen material (Fig. 5).

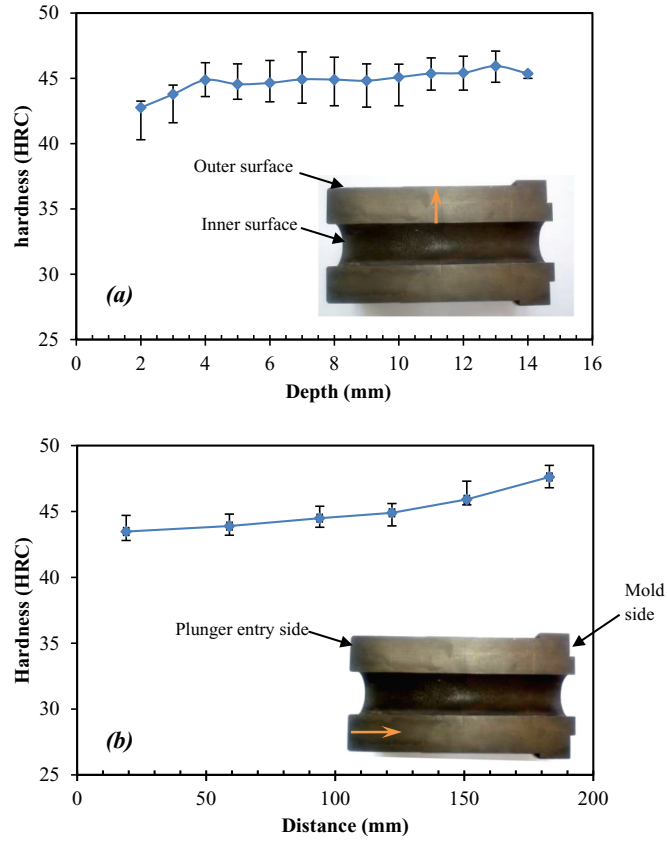
Fig. 7. Hardness shot-sleeve profiles, (a) from the entry to the mold zones, (b) from inner to the outer surfaces.

The hardness profiles were measured, on a shot-sleeve longitudinal section (Fig. 6 (b)) polished until mirror state, from the entry plunger zone to the mold side and from the inner to the outer surface (Fig. 7). These profiles are performed with a Vickers hardness machine using a load of 15 kg. The measured profiles reveal that the hardness appears to be constant for all tested samples.

average of measured hardness is about  $44.8_{-2.4}^{+3.8}$  HRC. This shows that the hardness was remained quasi-constant even after a few thousands of thermal heating and cooling phases (more than 74,000 cycles) and which indicate that the mechanical behaviour of the material is stable (i.e. absence of significant cyclic hardening or softening) under service conditions. Furthermore, micro-hardness measurements were performed with a Wilson hardness machine 402MVD using a load of 1 kg at a distance of approximately 400  $\mu\text{m}$  from the inner surface. The average of measured micro-hardness is about  $49.8_{-6.4}^{+5.5}$  HRC. This result proves that is no significant increase of the hardness from the heart to the inner surface of the shot-sleeve.

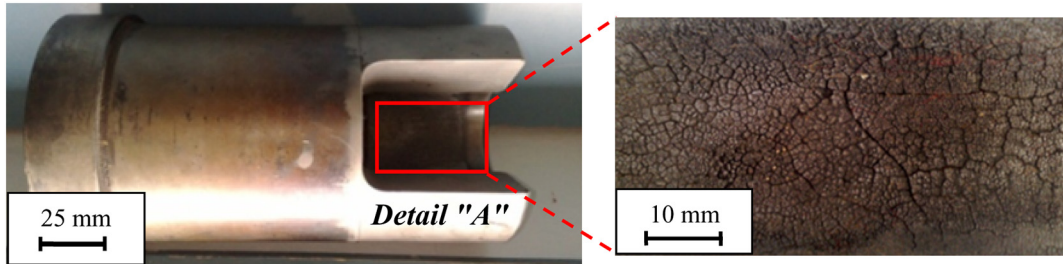
Fig. 8. Cracks network observed on the inner surface of the damaged shot-sleeve.

The second shot-sleeve was cut with a wire EDM machine according to their longitudinal direction to examine the integrity of the damaged surface (Fig. 8). After that, the cut-out parts are subjected to a surface cleaning operations: A chemical pickling with an alkaline solution using a dilute nitric acid was performed, at room temperature, to eliminate all traces of oxides. Then, the damaged shot-sleeve surfaces were subjected to a preliminary assessment with a naked eye to identify their major damage features. The examined surfaces (Fig. 9) clearly show the presence of a cracks network on the inner shot-sleeve surfaces.

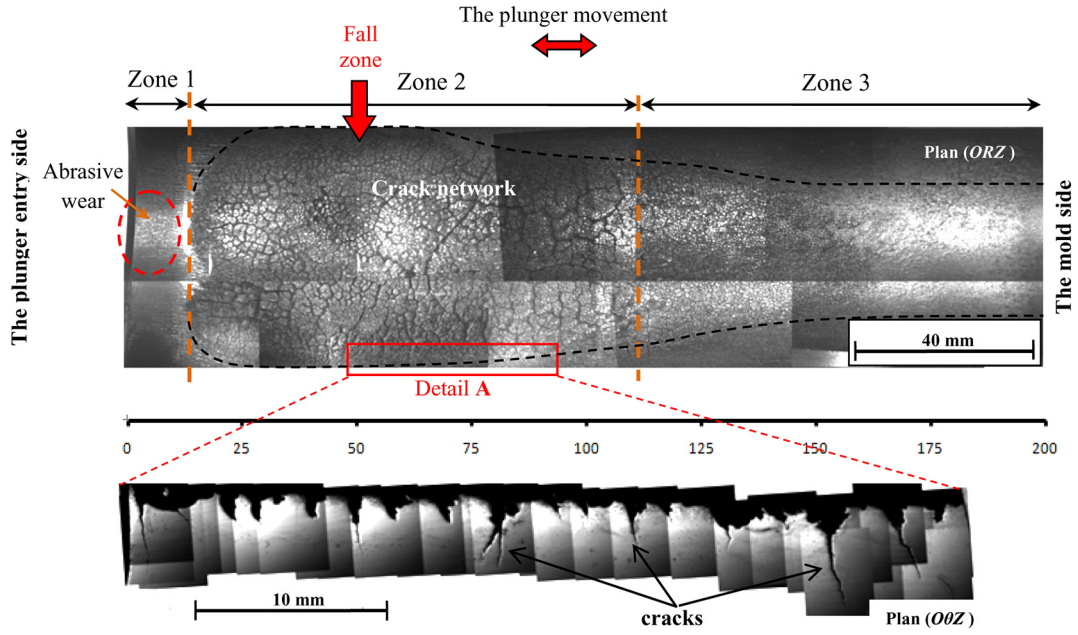
Fig. 9. Shot-sleeve inner surface damage observed with a digital camera.

A finer observations of the shot-sleeve inner side were carried out after a longitudinal cut (Fig. 6 (b)). The examination of the damaged surfaces was made using an experimental device equipped with a digital *Baumer*® camera *GIgE* (8 bits). This camera is equipped with a CCD sensor allowing to have a resolution of  $1624 \times 1236$  pixels. Several photos are taken and then assembled by means of Photoshop® software to obtain a large image that cover the entire shot-sleeve examined surface (Fig. 9). This surface reveals the presence of three different zones. The first one is located in the plunger entrance side. It presents a number of scratch according the longitudinal direction which corresponds to abrasive wear caused by the friction between the plunger and the shot-sleeve. The second one corresponds to the first zone which enter in contact with the molten metal ( $T = 950^\circ\text{C}$ ). It undergo cyclic thermal shocks. This zone appears to be the most damaged surface in the shot-sleeve. It presents a dense crack network sign of the thermal fatigue. In addition, the investigation of this zone according to the  $O\theta Z$  plan shows that some cracks, after initiation, were propagated in depth along the radial direction (Detail A). The last zone reveals also the presence of a crack network however it is less dense compared to this observed in the 2nd zone (Fig. 9).

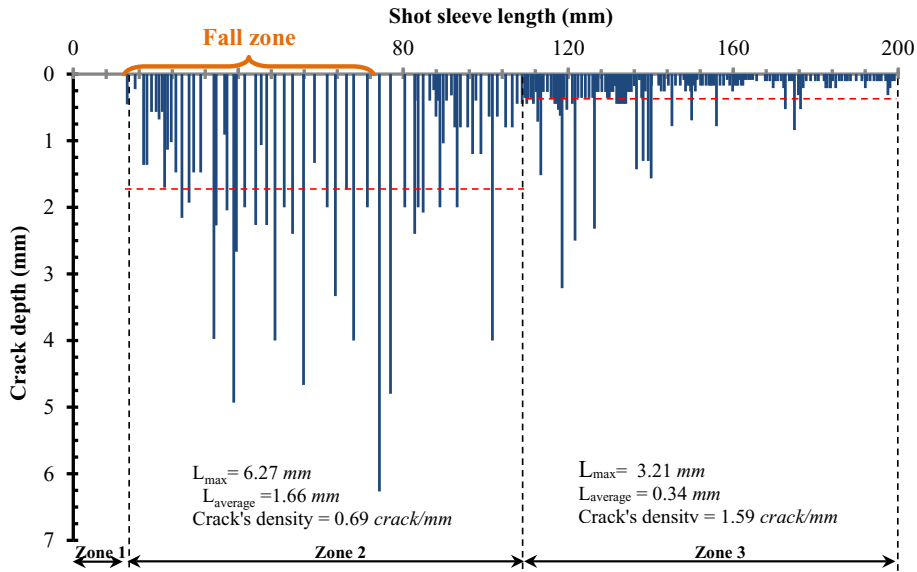
Fig. 10. Crack lengths distribution along the shot sleeve (longitudinal section  $\theta = 0$ ).

In this section, a meticulous investigation on the cracks distribution and density was performed by means of longitudinal and transversal observations (Figs. 10 and 11). The cracks depth according to the axial distance was presented in Fig. 10. It is to be noted that the cracks depth trend along the shot-sleeve follows the Gaussian distribution. Fig. 10 shows that the cracks depth is maximal around the zone 2, which corresponds to the casting zone (fall zone). This zone is characterized by a maximum crack length and average values of  $6.23\text{mm}$  and  $1.66\text{mm}$  respectively. In zone 3 the cracks deep is less than those observed in zone 2 nevertheless their density is more pronounced (*i.e.*  $1.59\text{crack/mm}$  in zone 3 against  $0.69\text{crack/mm}$  in zone 2). The presence of the shielding effect between neighbouring cracks existing in zone 2 cause the propagation slows down of the smaller cracks and only a few of the biggest ones continue to propagate. Such a phenomenon was observed in many applications in which the thermal fatigue was the main cause of damage [19–20,28].

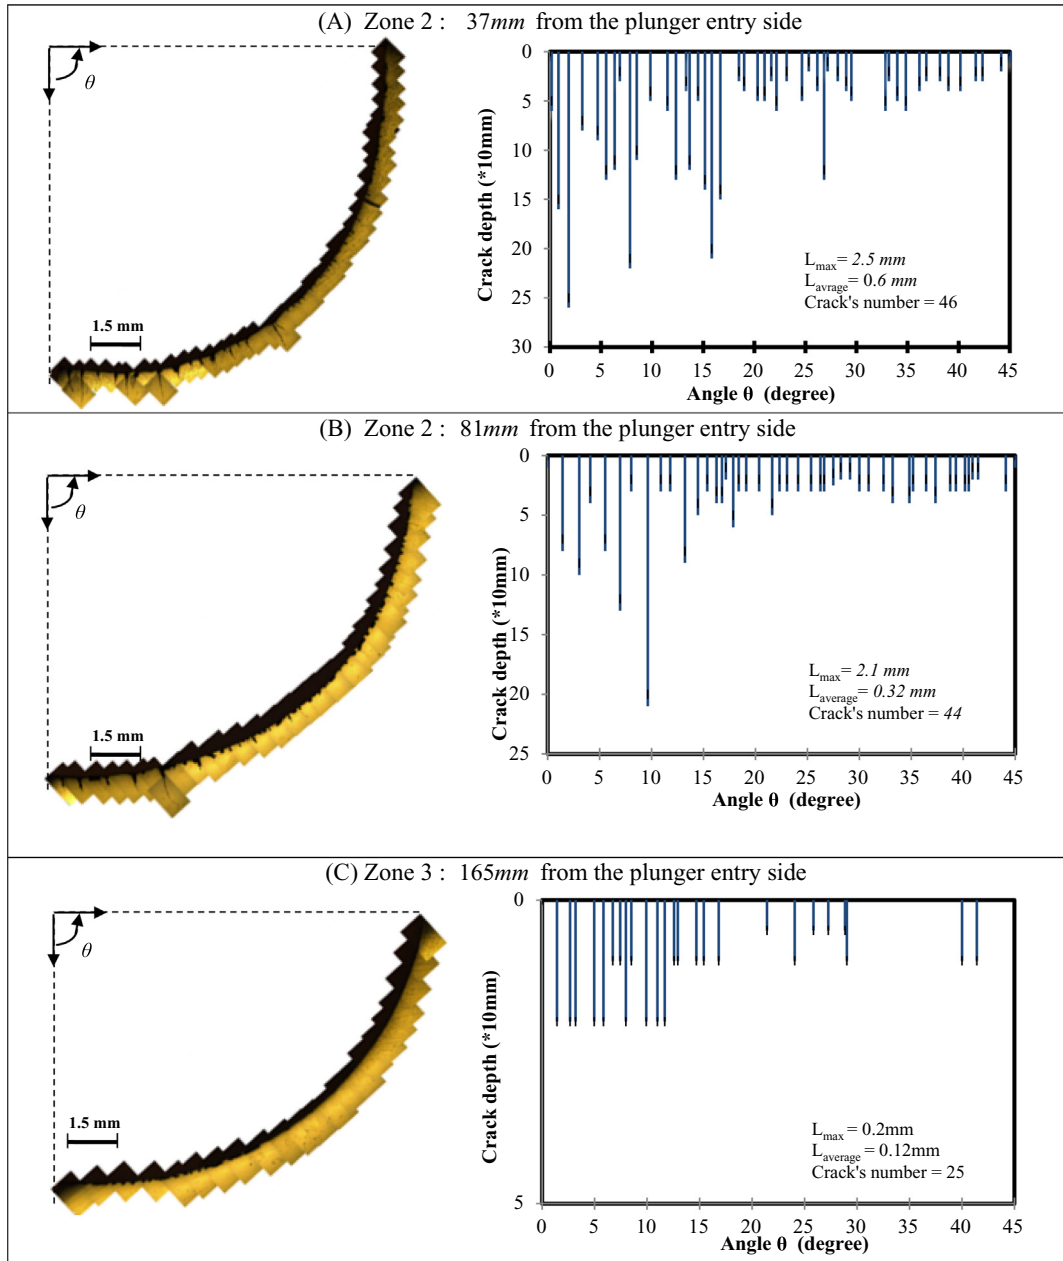
Fig. 11. Crack distribution of damaged shot-sleeve in cross-sections A, B and C.

The cracks depth investigation from the centre of shot-sleeve ( $\theta = 0^\circ$ ) to the shot-sleeve horizontal plane ( $\theta = 45^\circ$ ) for every shot-sleeve cross-sections A, B and C (Fig. 11). It is obvious that the maximal depths are sited at the level of the zone of casting. This result can be explained by thermal fatigue, oxidation and erosion by the molten brass flow which results in removal of superficial layer.

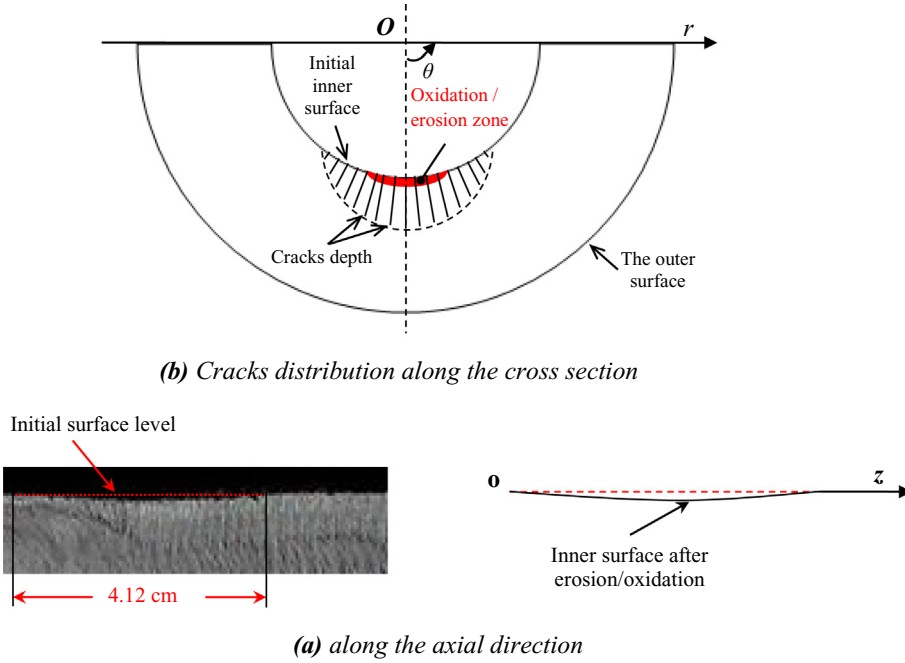
Fig. 12. Oxidation / erosion effect in the fall zone (Zone 2) of the shot-sleeve.

The initial level of the shot–sleeve casting zone (cited in zone 2) was decreased probably due to oxidation and erosion effects as shown in Fig. 12. The cracks situated surroundings the shot–sleeve centre (near  $\theta = 0^\circ$ ) are in reality longer compared to their effective length due to the small decrease of the shot sleeve inner surface level produced after the oxidation / erosion effect. Others micro cracks are totally removed what favoured the propagation of persistent cracks because the motive force was located in them, is confirmed by previous research [1,29].

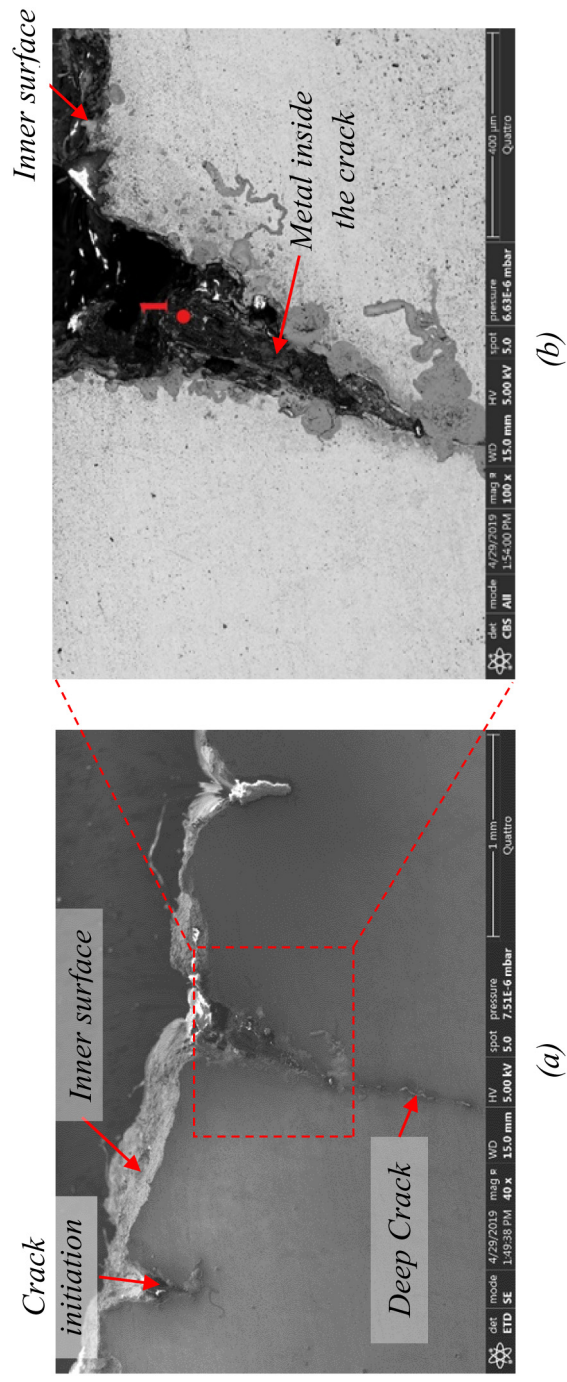
Fig. 13. SEM observation of a damaged shot sleeve cross-section: (a) Short (initiation) and deep crack, (b) Zoom on the examined crack with EDS (point 1).

In addition, in order to more understand the mechanisms leading to the shot sleeve failure, a sample of the cross-section surface was examined using SEM (Fig. 13) and Energy Dispersive X-ray Spectroscopy (EDS) to identify the chemical composition of the metal inside cracks (points 1 in Fig. 13 (b)) (Table 4). According to Fig. 13 (a), the cracks tend to propagate perpendicular to the damaged surface. The initial growth of thermal fatigue cracks is facilitated by an oxidation attack on the crack surface, which forms the Fe, Cu, Zn, Cr, Mo, Si and O rich layer (Table 4). The presence of brass and oxides, in the cracks increases plastic yield ( $R_{p0.2}$ ) and compressive stresses during the heating phase of the thermal cycle [30]. As a result, the tensile stress is further increased during the cooling phase and can leads to the acceleration of the crack growth rate. In addition, the tensile stresses applied on the shot-sleeve inner surface during the cooling phase combined with the erosion phenomenon caused by the molten brass fall in the second zone leads to a local failure, which promote the opening of thermal cracks [13]. These cracks act as channels allowing oxygen to penetrate down to the crack tip area and oxidize both shot sleeve and the filling material. Solidified particles down on the crack act as an obstacle for its closer and the size of the crack openings in the filling material indicates the amount of brass that will fill the crack during the next cycle [20].
